# Southwest Florida LEPC District IX Commodity Flow Study Final Report

Advanced Planning  
Consultants, LLC.

September 2015

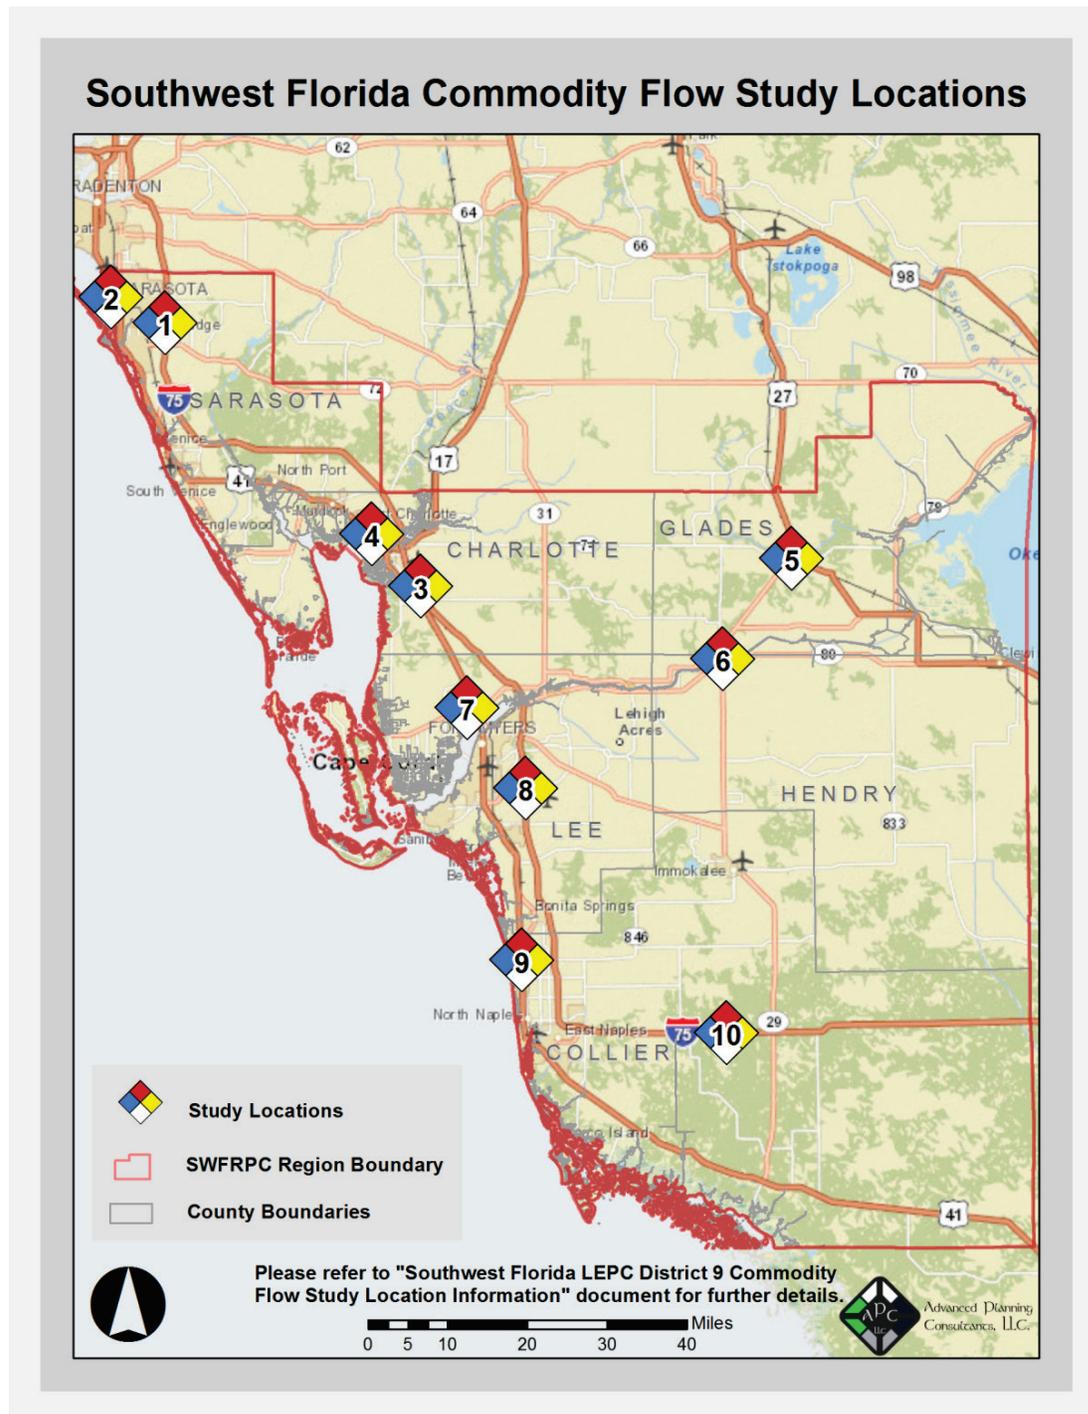
Figure 1: Commodity Flow Study Location Map

The observation locations illustrated below were selected for various reasons including, but not limited to: proximity to major roadways/highways, clear visual of all hazardous material transportation vehicles traveling on the identified roadway/highway, personnel safety, and equal survey information gathered in each of the six counties within the Southwest Florida region. Additional information regarding these locations can be found in Appendix B.

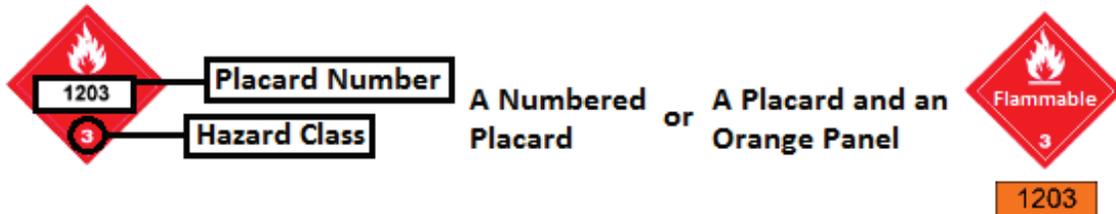
Figure 2: Example of Placard and Panel with ID Number

To determine the type of commodity being carried within a vehicle, placards were examined. The 4-digit ID Number may be shown on the diamond-shaped placard or on an adjacent orange panel displayed on the ends and sides of a cargo tank, vehicle, or railcar (Figure 2 below).

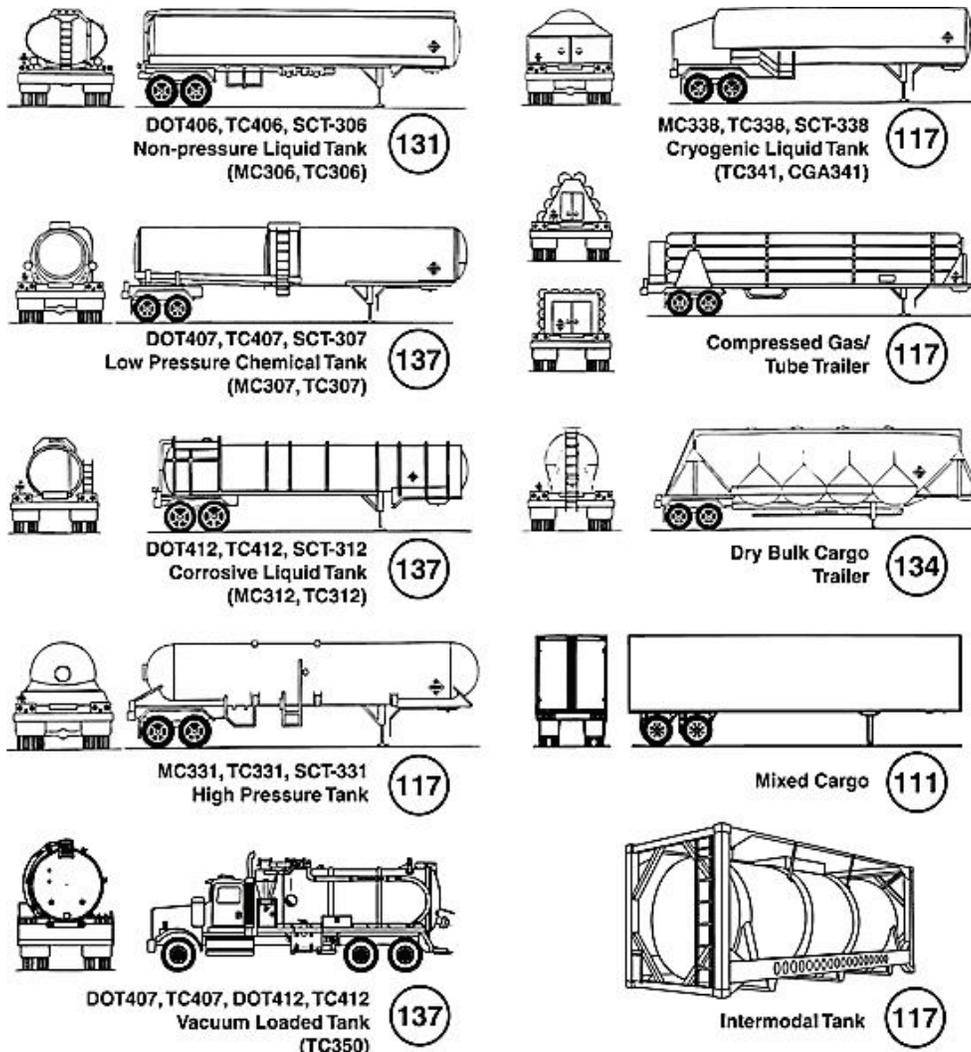
Figure 3: General Road Trailers

The identification of trailer types is an additional option for responders to use in determining the risk of a commodity if it cannot be identified by other means. Below are examples of general road trailer silhouettes:

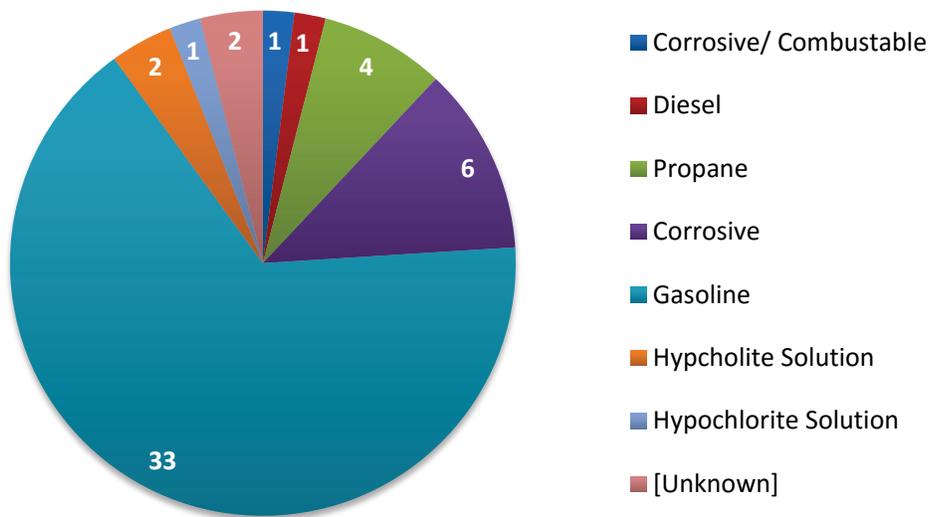
Figure 4: Sarasota County Interstate 75 - Total by Commodity Type

The Interstate 75 corridor had one observation point within Sarasota County. This point included the northbound/southbound traffic from the parking lot of 6010 Cattleridge Drive. The site was observed for one, two hour period. During the observation period, fifty (50) vehicles transporting hazardous materials were recorded\*. Of the vehicles recorded, thirty three (33) were gasoline trucks, six (6) were transporting corrosive chemicals, and four (4) were transporting propane. The following chart shows the total observed commodity types for the site.

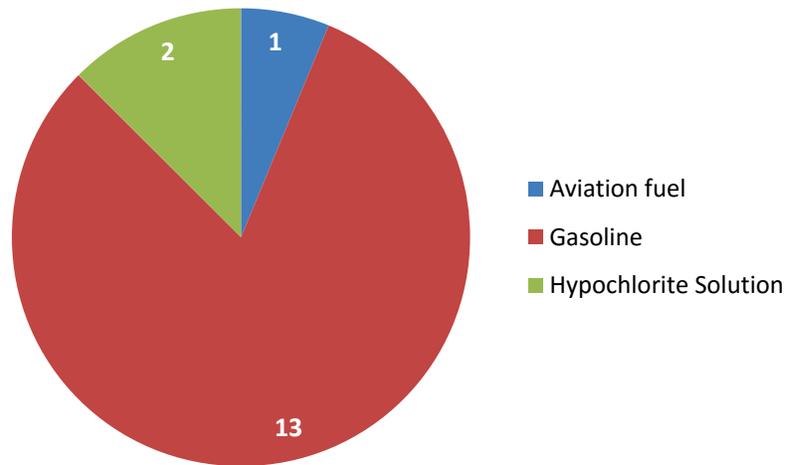
Figure 5: Charlotte County Interstate 75 - Total by Commodity Type

The I-75 corridor had one observation point within Charlotte County. This included the northbound/southbound traffic at Punta Gorda Weigh Station and Rest Area. This site was observed for one, two hour period. During the observation period, sixteen (16) vehicles transporting hazardous materials were recorded\*. Of the vehicles recorded, thirteen (13) were gasoline trucks, two (2) were transporting a hypochlorite solution, and one (1) was transporting aviation fuel. The following chart shows the total observed commodity types for the site.

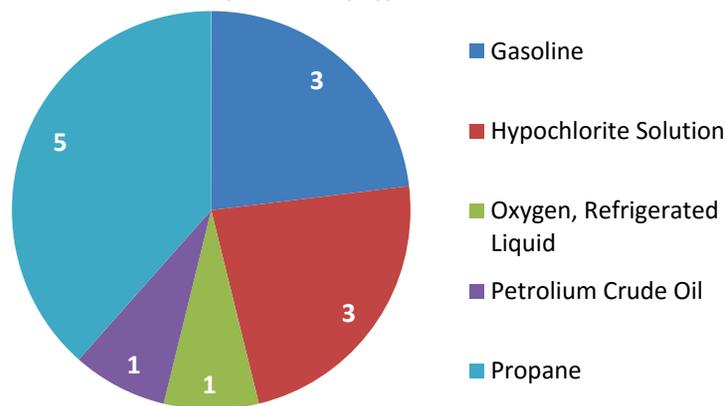
Figure 6: Hendry County Interstate 75 - Total by Commodity Type

The intersection of State Road 80 and US-29 corridor had one observation point within Hendry County. This included the northbound/southbound US-29 traffic and the eastbound/westbound traffic of SR-80 at the intersection. This site was observed for one, two hour period. During the observation period, thirteen (13) vehicles transporting hazardous materials were recorded. Of the vehicles recorded, five (5) were transporting propane or propane cylinders, three (3) were transporting a hypochlorite solution, and three (3) were transporting gasoline. The following chart shows the total observed commodity types for the site.

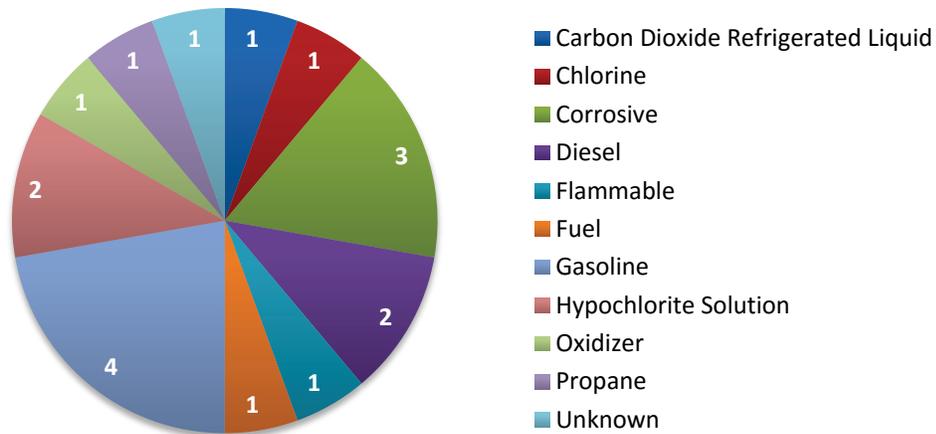
Figure 7: Lee County Interstate 75 - Total by Commodity Type

The Interstate 75 corridor had one observation point within Lee County. This included the northbound/southbound traffic at mile marker 123 in front of Germain Arena. This site was observed for one, two hour period. During the observation period, eighteen (18) vehicles transporting hazardous materials were recorded. Of the vehicles recorded, four (4) were transporting gasoline, three (3) were an unknown corrosive, two (2) were transporting diesel, and two (2) were transporting a hypochlorite solution. The following chart shows the total observed commodity types for the site. Additional information on the vehicles can be found in Appendix C.

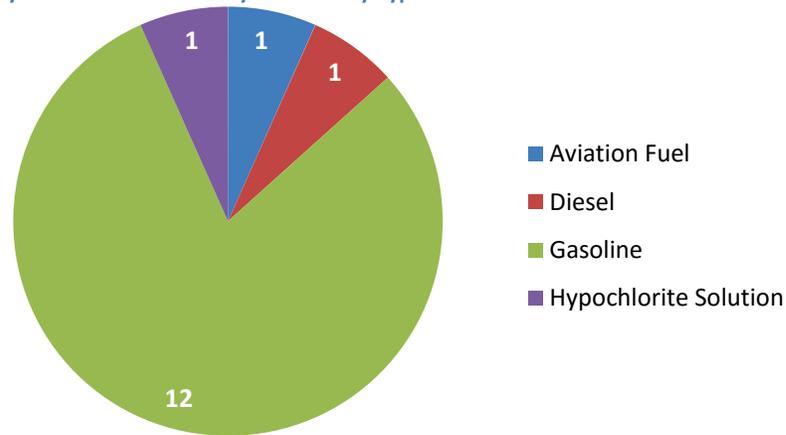
Figure 8: Collier County Interstate 75 - Total by Commodity Type

The Interstate 75 corridor had one observation point within Collier County. This included the eastbound/westbound traffic between mile marker 92 and mile marker 93. This site was observed for one, two hour period. During the observation period, fifteen (15) vehicles transporting hazardous materials were recorded. Of the vehicles recorded, twelve (12) were transporting gasoline, one (1) was transporting diesel, one (1) was transporting aviation fuel, and one (1) was transporting a hypochlorite solution. The following chart shows the total observed commodity types for the site. Additional information on the vehicles can be found in Appendix C.

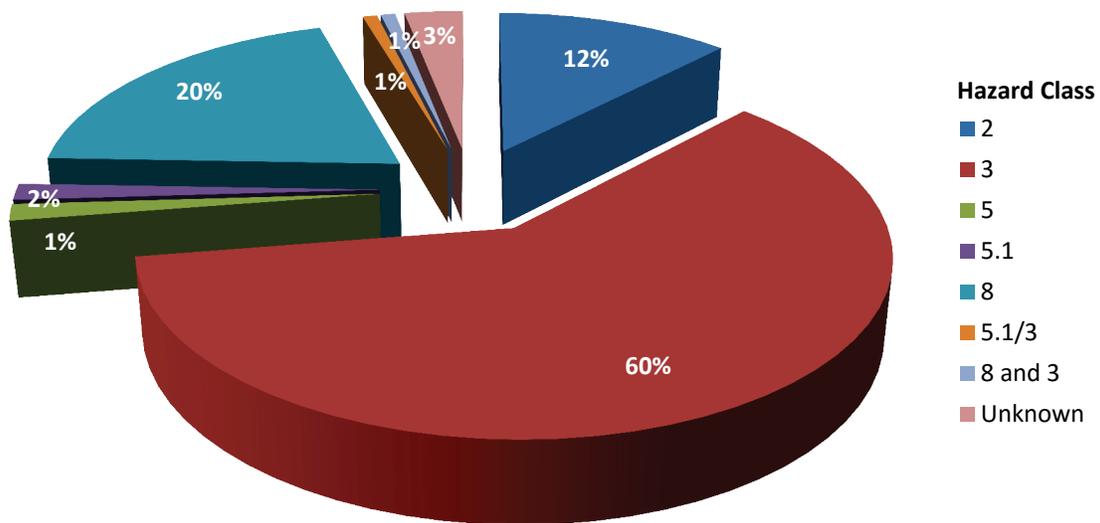
Figure 9: District IX Conclusion - Percent (%) by Hazard Class

After examining the data from this survey several conclusions emerged. First, by far the most frequently carried classification within the region is DOT Class 3 – Flammable Liquids, which was observed over 60 percent of the time (see figure 6). Second, the most common vehicle type observed transporting hazardous commodities was the MC 306 tanker representing non-pressure liquids. This was observed 59 percent of the time. Finally the most common commodities identified within the region were: gasoline (52.6%), propane (9.9%), unknown corrosives (9.9%), and hypochlorite solution(s) (9.2%).
